SANDEL

SN3308 Pilot's Guide

Effectivity and Errata

Date: 7/10/2008
Revision: 2.11
Applies to: SN3308 Software 2.11
Pilot's Guide 82001PG-C
90106PG-C

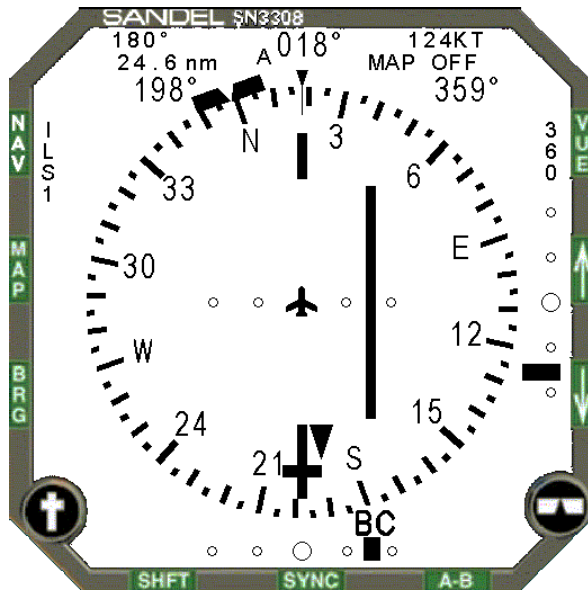
3. Back Course Approach Operation:

When flying a back course approach, the course pointer should be set to the published front course. In software versions 2.10 and later, the bottom CDI will automatically reverse sense when the course pointer is more than ± 90 Deg from the lubber line. The label 'BC' will appear above the bottom CDI during a back course approach as a reminder to the pilot as shown in the diagram below.
